Spatial Analysis of Cultural Agglomeration in a Monastery in Cyprus: A Non-Chronological Reading Prior to The Conservation Process

Keywords: *Acheiropitos, monastery, layering, accumulation, Cyprus*

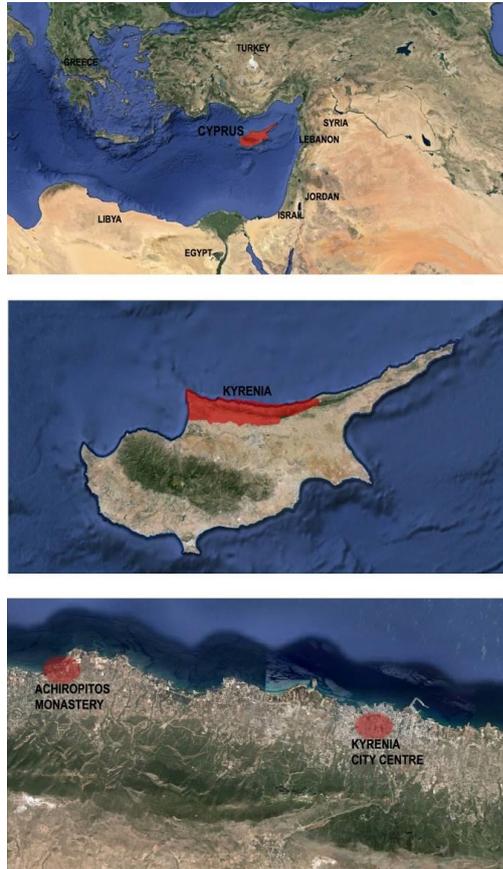
Figure 1. Location of Cyprus, Kyrenia and Achiropitos Monastery

Acheiropitos Monastery is located nearly eight kilometres west of Kyrenia in the Lapithos district of Cyprus (Figure 1). The site is near the coast and the surrounding settlement consists of military bases (Figure 2). The monastery measures 90 metres from east to west, and 56 metres from north to south. The five-decare area

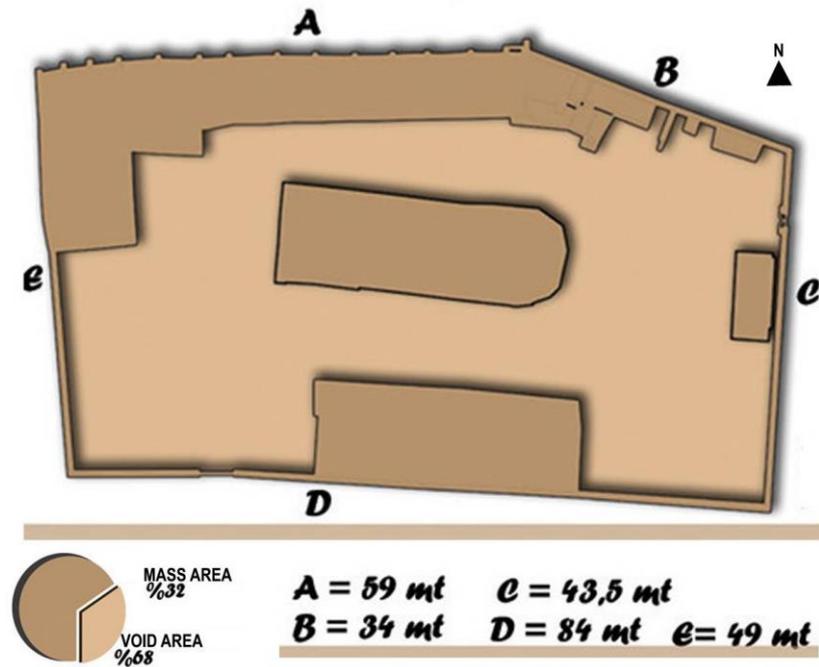
Figure 3. Masses and voids in the site plan

contains three historical monumental masonry buildings and two small modern concrete additions (Figure 3).

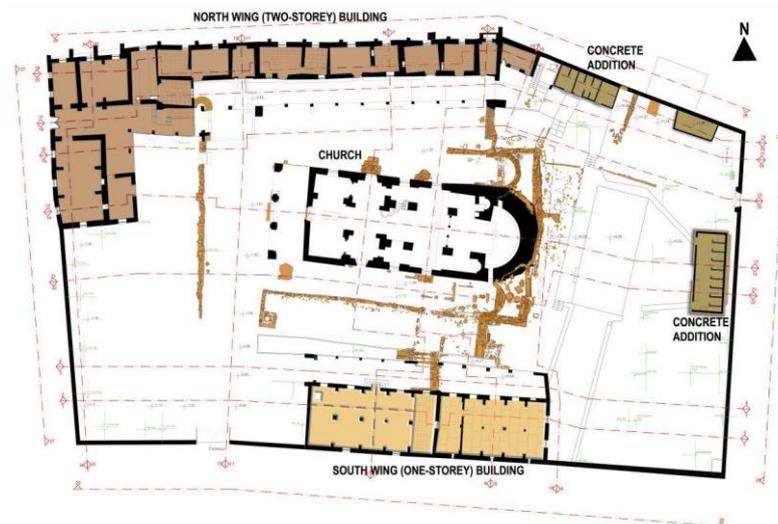
Figure 4. Survey drawing of the site plan, enclosed spaces

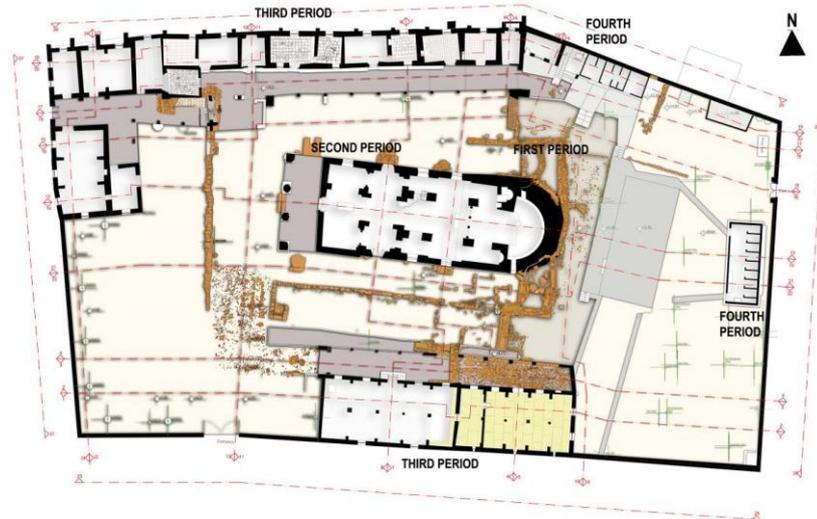
Figure 5. Survey drawing of the site plan, semi-enclosed spaces

Before delving into specific examples of individual building to building, I will describe the traces of the previous periods observed at the site (Figure 5). As mentioned above, there are five buildings on the site, built at different scales and in different centuries. Construction started in the fifth century and continued until the beginning of the twenty-first century (2). The dating issues are based on historical sources, which are detailed below, particularly in the descriptions of the individual buildings. This article will try to analyse the buildings by focusing on the traces of changes and additions in order to find out the characteristics of the period(s) of the buildings. The traces of previous periods do not always provide exact dates, but the aim of this article is to show the complexity of the periods that can be seen on the building surfaces rather than to focus on the specifics of each period. In addition to the buildings exist present day, there are also some traces, which provide limited information about architectural elements of buildings that cannot be accessed currently, including the old enclosing wall, the bell tower and the remains of the wall corner.

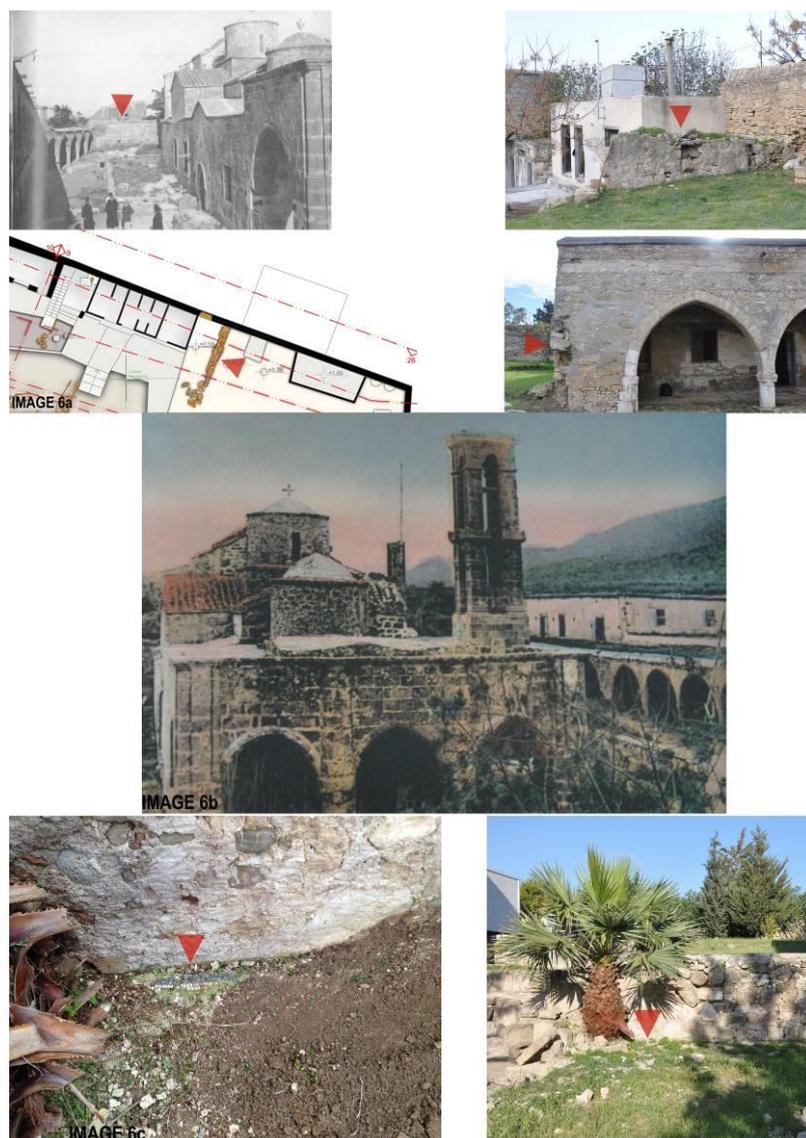
Figure 6. (a) The historical image, current status, architectural survey drawing of the old enclosing wall, corner of the single-storey building (Luke, 1957, 102) (b) The historical image of the bell tower (Lazarides, 2005, 159) (c) Image of the current status

The Old Enclosing Wall has been mostly demolished, but it can be sighted from a photograph in Luke (Figure 6a) (Luke, 1957) that it formed the boundary of the monastery. The corner of the one-storey building has some outcropping stones, and this building was probably related to the enclosing wall. As can be clearly seen from the site, the old enclosing wall has been demolished and present enclosing wall has been built with the traditional stones of the site. Unfortunately, there is no document that gives the exact date of enlarging the site, but it was most probably done during the first half of the twentieth century. The Bell Tower's photographs (Figure 6b) (Lazarides, 2005) from different periods show its architectural concern, but there is no trace of it in its original location. There are some Remains of a Wall Corner as highly sophisticated mosaic designs inside the church and south wing building. In addition to these, two different areas of mosaic patterns were found at the site, near the remains of the wall corner in 2014 (Figure 6c). This specific corner is now unconnected with any other architectural remains, but it can be assumed from the remaining mosaic pieces and from traces of a window line in the wall that there was a closed or semi-open space here. These wall and tower remains can be understood to be remnants of currently unreachable destroyed architectural elements seen at the site. In fact, all the buildings at the site have remnants from different periods.

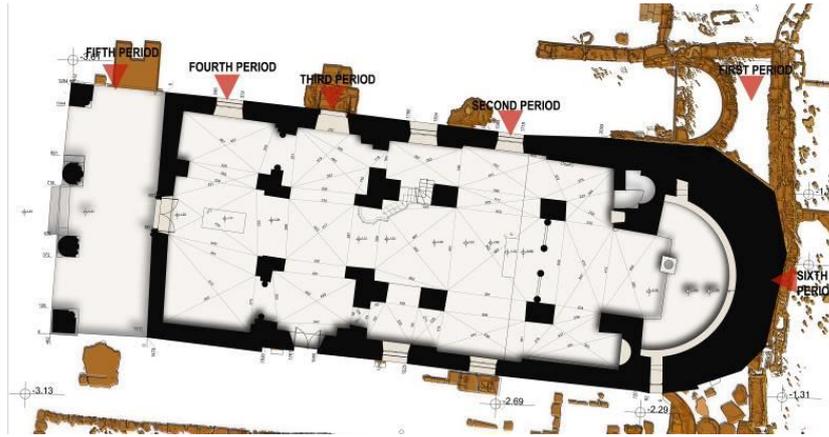
Figure 7. Survey drawing of the church building, floor plan

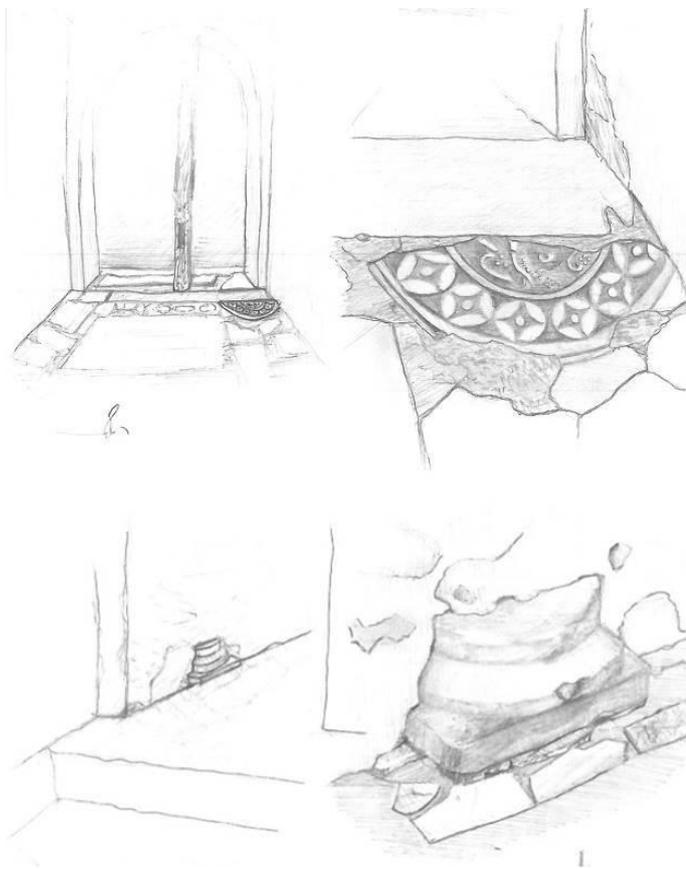
Figure 8. Sketches of agglomeration cases

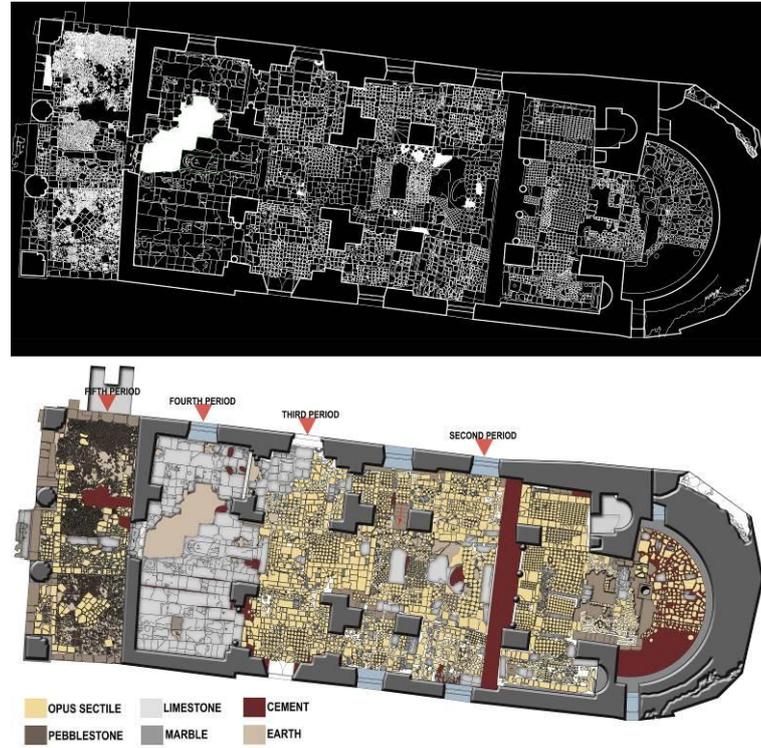
Figure 9. (a) Survey drawing of the church building, mosaics (b) analyses of the church building, mosaic stone types (c) image of the tombstone

The covering material of the church floor is one of the most useful tools for analysing the building periods (Figure 9a). The changes in materials used can be seen clearly through the material analyses (Figure 9b). The covering material of the church floor is an opus sectile-type mosaic as far as the third layer. The mosaic covers the church floor throughout the second and third layers ending at the fourth layer: the interior narthex. Limestone is used as a covering material here forming the fourth layer (4). For the fifth layer, a semi-open space (the exterior narthex) pebble stones

are used for the most part. However, opus sectile mosaic tiles also appear here. The differences between the covering materials used on the church floor can be observed most clearly in the section that survives from the fourth stage of the building's history. The limestone used in this section that belongs to the fourth stage of the building agglomeration can be clearly distinguished from the sections that survive from the third and the fifth stages.

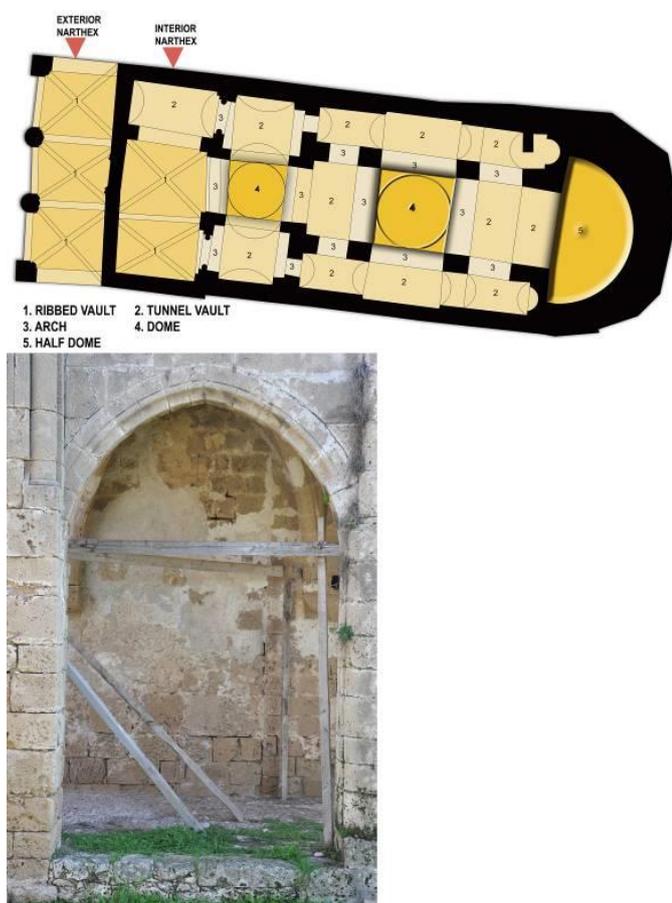
Figure 10. (a) Survey drawing of the church building, ceiling plan (b) Image of the exterior wall from narthex

The ceiling plan of the church displays symmetry where vaults, domes and arches are used to cover the ceiling (Figure 10a). But at the north side of the interior narthex, there is an irregularity in the organisation of the ceiling. Although the whole ceiling of the interior narthex is covered with a ribbed vault, in one specific area, a tunnel vault can be seen. This difference may have occurred for numerous possible reasons during the construction process, but most likely this area was demolished and rebuilt later. This line of reasoning is taken because of a small yet significant trace at the surface that resembles a line of a gap closed later on at the west exterior wall of this specific part (Figure 10b).

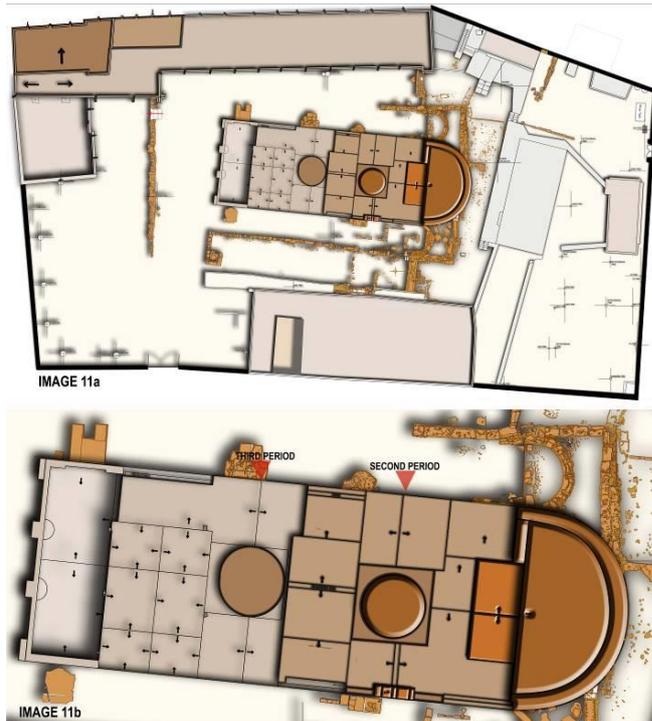
Figure 11. (a) Survey drawing of the site, roof plan (b) survey drawing of the church building, roof plan

The roof plan of the church is one of the most significant parts of the building to demonstrate the process of agglomeration (Figure 11a-11b). This is because the layers can be seen clearly, and the design of the building roof is aesthetically striking, with the different heights of the domes at the upper level. The core of the building, which can be termed the second layer due to the remains of the basilica, can be read clearly from this drawing in Figure 11a and Figure 11b. The elements that belong to the second period include the domes and gable roofs. The third layer also has a dome, which is lower than the one from the previous period. There is a unique detail at the intersection of these two layers. There is a window in the west wall of the roof that marks the boundary of the layer from this period. When the new layer started to be built, i.e. the third period in the history of the roof, this window was not closed. Instead, a new dome was built just beside the wall. The gap left between these two walls is only 17 centimetres and the window, 60 centimetres in height, faces this tiny gap. The window can be seen from the roof level; it has been closed from the inside. This relationship can be clearly seen from the longitudinal section of the church (Figure 12a, 12b).

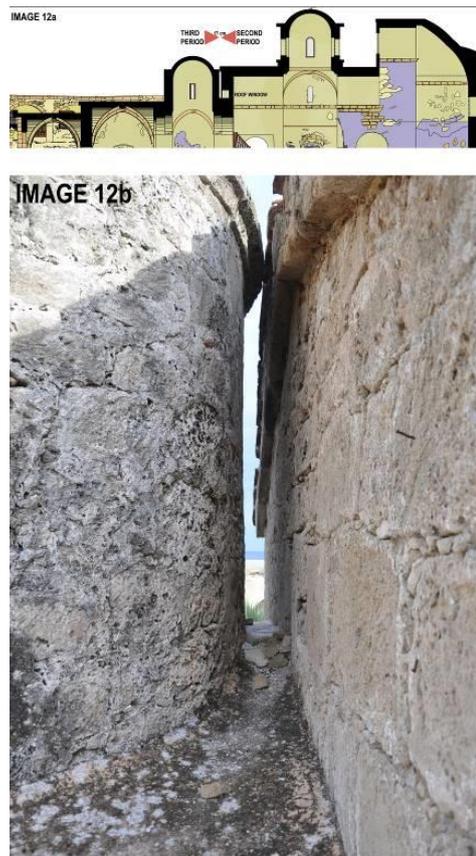
Figure 12. (a) Longitudinal roof section of the church building (b) image of the roof window

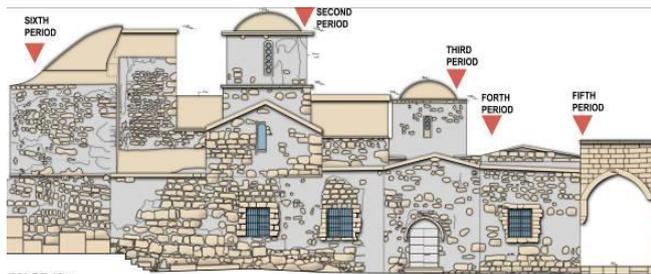
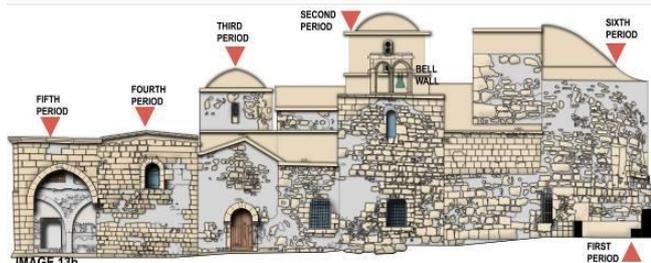
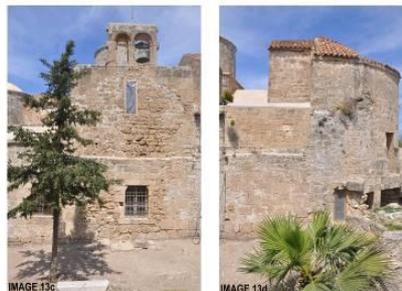
Figure 13. (a) Survey drawing of the church building, north elevation (b) survey drawing of the church building, south elevation (c) image of the bell tower (d) image of the raised wall

The layers of the church can also be examined from the north and south façades. The north elevation gives information about the boundaries between the second and third periods, the third and fourth periods, and the fourth and fifth periods (Figure 13a). The south façade also shows the same boundaries clearly, via the interventions from different periods (Figure 13b). Besides the layering that is described above, there are also some connections between different periods that can be defined as an accumulation. These connections can be seen from the elevations. The south facade of the church has further traces of accumulation. In the second period, changes in the building surfaces indicate that the bell wall of the church was added later on. The trace of that addition can be seen from the facade. The earlier roof was gabled and some basic repairs and minor additions were made to the surface in order to make it flat (Figure 13c). Another case of accumulation can be seen near the right side of the bell wall where the adjacent wall is built in a different style of masonry (Figure 13d). The relationship of this part of the elevation with the roof plan gives the impression of a repair of the roof valley.

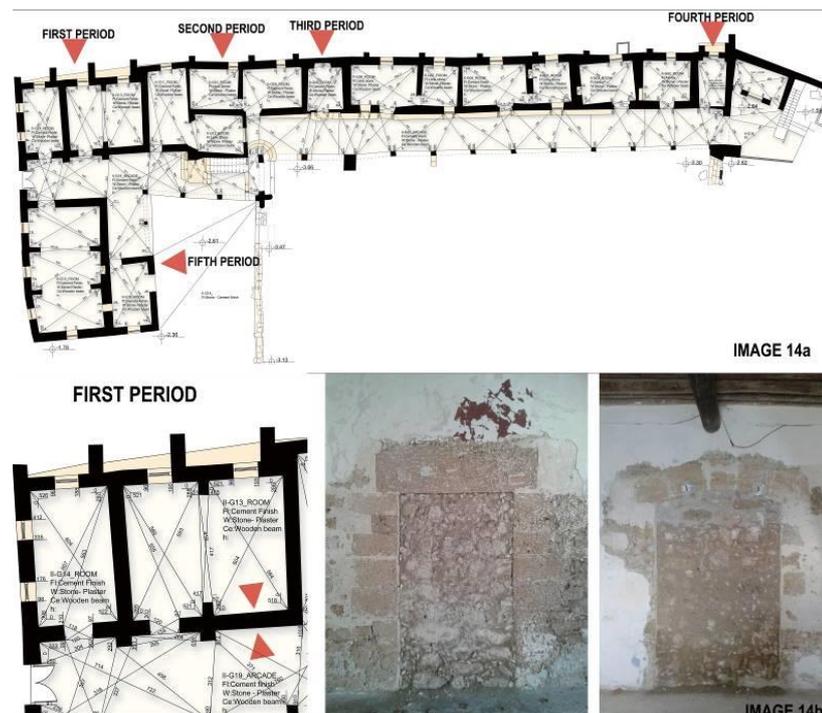
Figure 14. (a) Survey drawing of the north wing building, ground floor plan (b) detailed plan, image of the filled door from first period

The first floor of the north wing was added at a much later date than the ground floor; in addition, the inner rooms of the ground floor show evidence of various periods (Figure 14a). The west corner of the building, with its three rooms, is the oldest part. A two-roomed building can be seen today (room numbers II-G 13 and II-G14 on the ground floor plan), but we can see from the traces of a closed door on the south wall of room II-G 13 that there were originally three rooms. The wall separating the room II-G 13 was demolished and an arch was built in its place. The door of the third room was blocked up and filled with brick: its traces can be seen where the plaster has been removed from the wall (Figure 14b). That original part (Rooms II-G 13 and II-G 14) was built in two storeys in the early stages and it is the oldest part of this building.

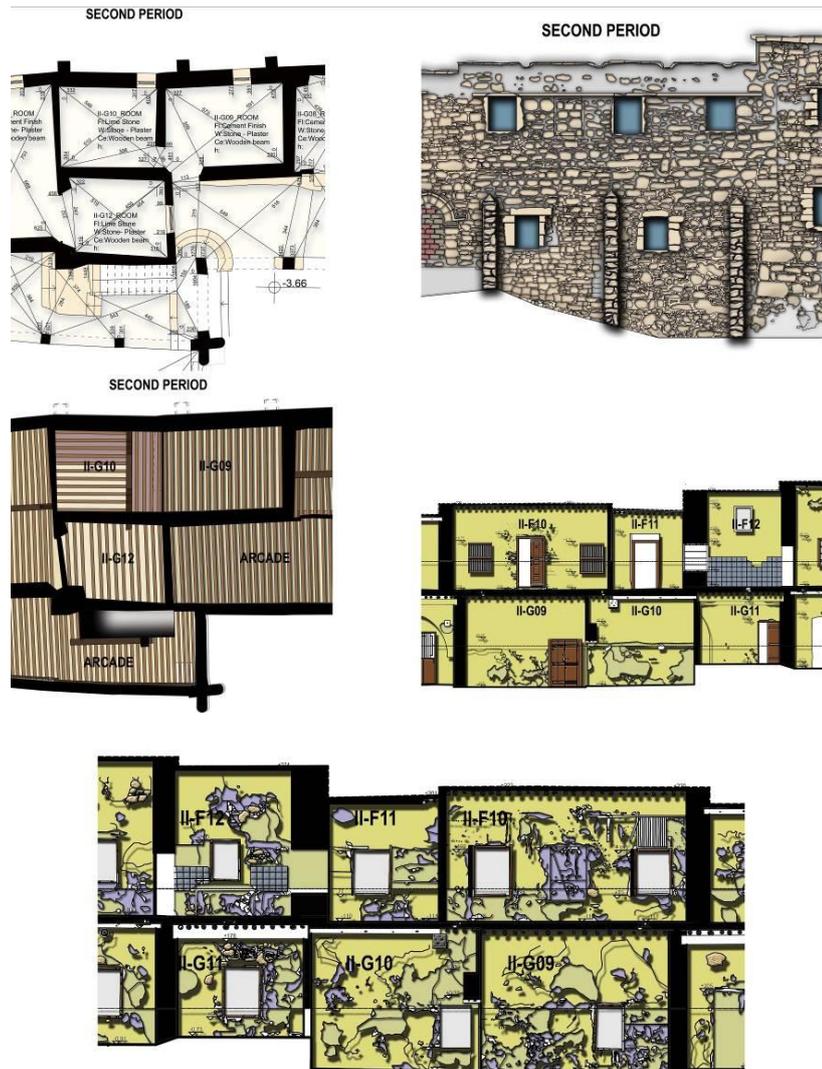
Figure 16. Detailed plan, sections, façade of second period

The second stage of the northern wing includes the core of the building, and is made up of rooms II-G 09, II-G 10 and II-G 12. This area looks like a unified mass from the north façade, particularly because of the common language of the buttress styles, which differ from the rest. However, from the interior perspective, the organisation of this group of rooms, and especially the ceiling plan, is very complicated. The analysis of the periods for this core area cannot be explained by the terminology of layering. Each surface, including walls, floors and ceilings, changed over and over again, so that there is much overlapping of the different layers. Therefore, it makes more sense to say that each period is accumulated here (Figure 16). Room II-G 10 has numerous irregular formations (5). The second, complicated stage ends with room II-G 09 and the third period starts with room II-G 08, which was not a room but an entrance in the original period.

12 shows overlaps of different periods. A column stands in the middle of the top step of the stairs. The following argument can therefore be made: the small section within room II-G 10 shown in Figure 16 could have formed the exact border of the original stairwell and room II-G 09 could have ended at the line of the main beam. Previously, there must have been a wall here, which could have been demolished and replaced by the main beam to create a new room. The direction of the small wooden beams also verifies this assumption.

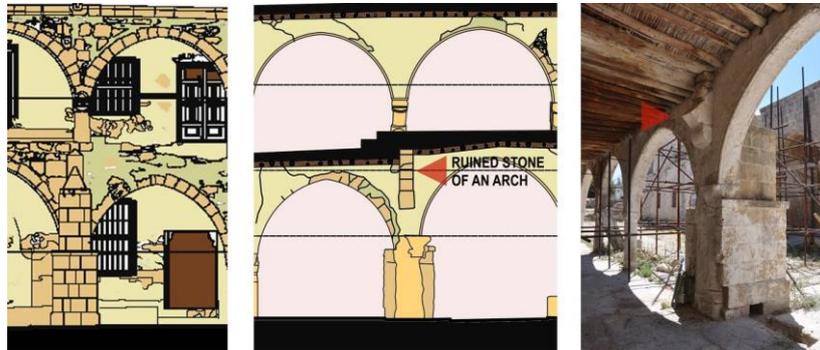
Figure 17. Detailed sections, image of the ruined stone of an arch

The third stage of the building starts with an entrance along the seashore in room II-G 08. Today, that entrance cannot be easily identified from the inside because it has been blocked in with a brick wall and plastered. However, the facade on the north side is not plastered and so the richly ornamented entrance archway can be seen. Another clue is hidden behind the supporting column, at the ceiling level, which is opposite room II-G 08, within the arcade. The small ruined stone is thought to be the trace of a former arch, which gives the impression of having been at one end of the building (Figure 17). It may be assumed that the building up to this point (i.e. up to room II-G 01) was constructed during the same period. There is another irregularity in room II-G 07, in that it has a different ceiling design; there are no other traces or clues that help identify the history of construction or period under repair. The reason for this change in the ceiling design of room II-G 07 is not clear (Figure 18). Peculiarly, this room has its entrance from the next room: that is, room II-G-06. This unusual spatial relationship is a typical characteristic of the rooms of this

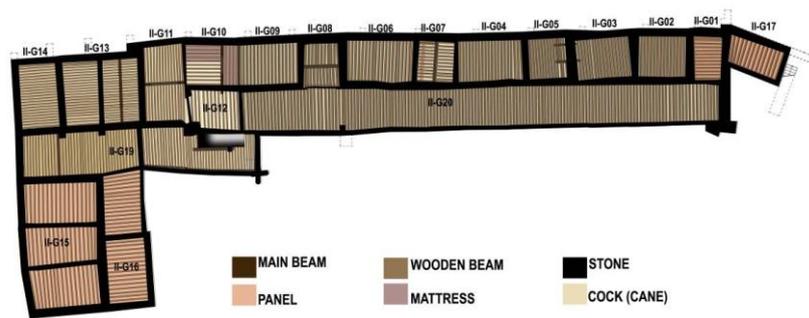
Figure 18. Survey drawing of the north wing building, ceiling plan of the ground floor

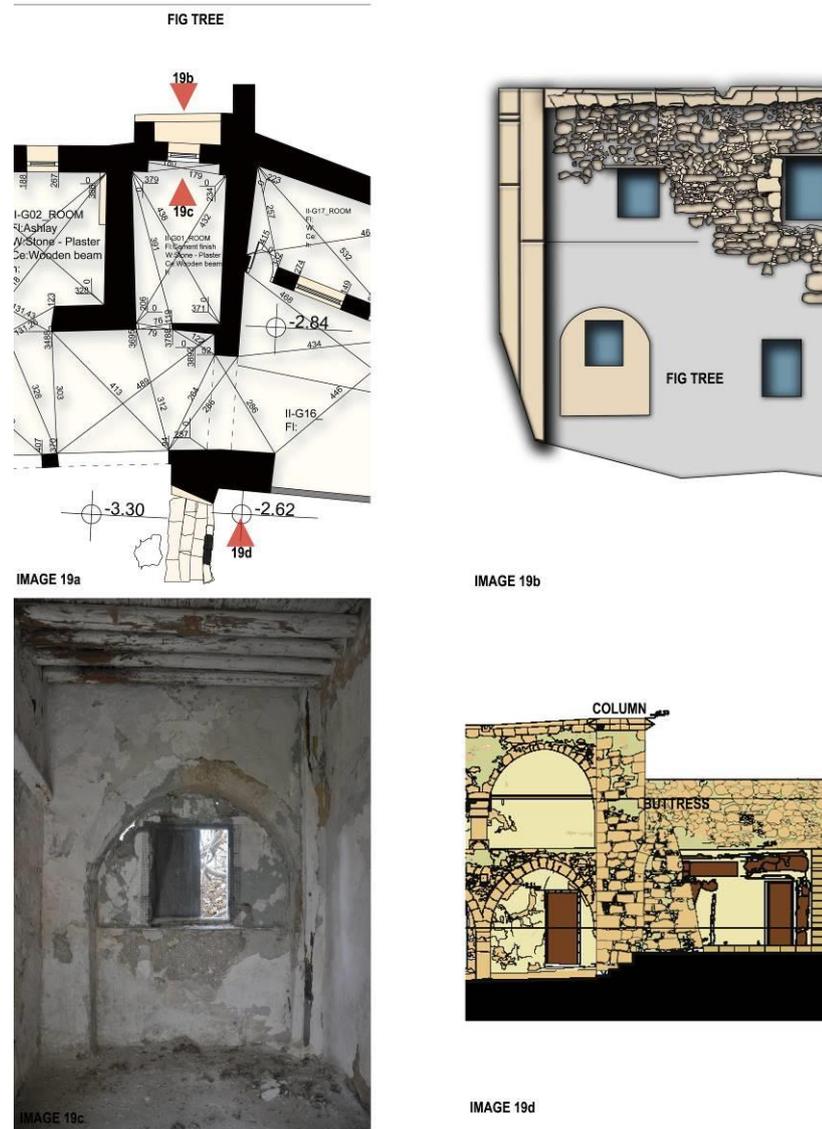
Figure 19. (a) Plan of the room II-G 01 (b) Survey Drawing of the North Façade of the room (c) Image of the room's north wall (d) Survey Drawing of the Column Footing

Room II-G 01 assumed to have been built at the fourth stage, as it contains some of the unfinished sections were also destroyed (Figure 19a). There are some building remains in front of the window at the north facade, but these cannot be accessed because of the density of wild trees here (Figure 19b). Nonetheless, an arch and a platform can be seen from a distance. The room might have been designed as another entrance, as the trace of a gap within the masonry is clearly visible under the window (Figure 19c). These traces of the arch are along the north side. However, this room also has traces of some ruins along the east side. In front of the room there is a huge column footing on which there are the remains of a broken archway (Figure 19d). The old photograph of (Luke, 1957) also shows the unfinished part at the point of the single-storey arcade (Figure 6a). From the examination of these architectural ruins, it can be assumed that room II-G 01 was a nodal point from which the building could have extended towards the north and east.

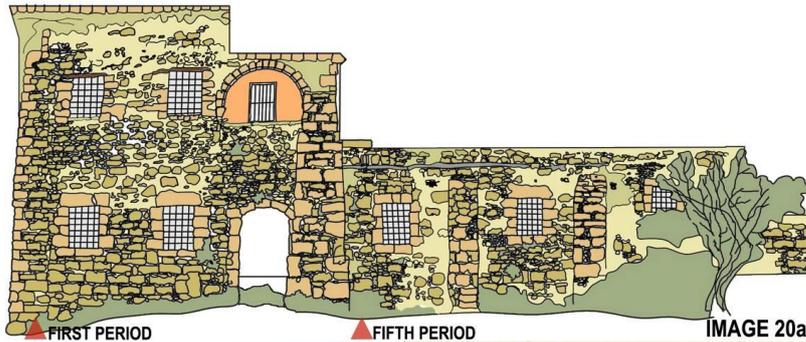
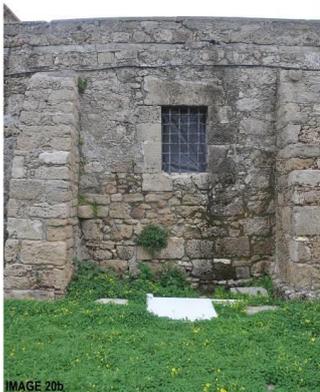
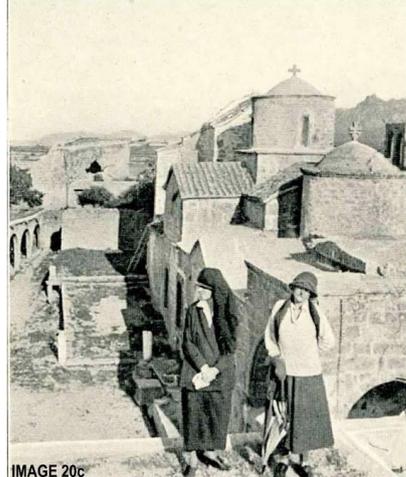
Figure 20. (a) Survey drawing of the north wing building, west elevation, (b) Figure of the elevation, (c) An image from the west addition of the north wing (The Other Cyprus, 2009)

In the north part of the building, there is an addition that may be dated to the fifth stage. This section has three different spaces of different characters and dates: Rooms II-G 15, II-G 16 and the arcade space at the corner. Even though it cannot be definitively asserted, the arcade and room II-G 15 seem to be older than room II-G 16. Room II-G 15, which is separated into three areas by arches, had some changes to its roof. The west façade of the building provides evidence for the original height of the building (Figure 20a). The horizontal line can be seen from the drawings; the remains of an old gutter also give information about the original height (Figure 20b). While the façade provides the evidence just discussed, a historical photograph (“The Other Cyprus,” 2009) yields completely different information about earlier periods (Figure 20c). Two women are standing in the foreground of the photograph; the entrance façade of the church can be seen in the background, which means that they must be standing on top of room II-G 16. What is noticeable is that the

ground level (meaning the surface of the roof) on which they are standing is today very high- higher than the gutter trace mentioned above. Thus, the level of the gutter, the level shown in the photograph, and today's roof level are all different. This area had various changes made to it, and, in a similar way to the core of this building (i.e. rooms II-G 09, 10, 12), the layering cannot be distinguished clearly. The agglomeration of different periods can therefore be defined with the term of accumulation.

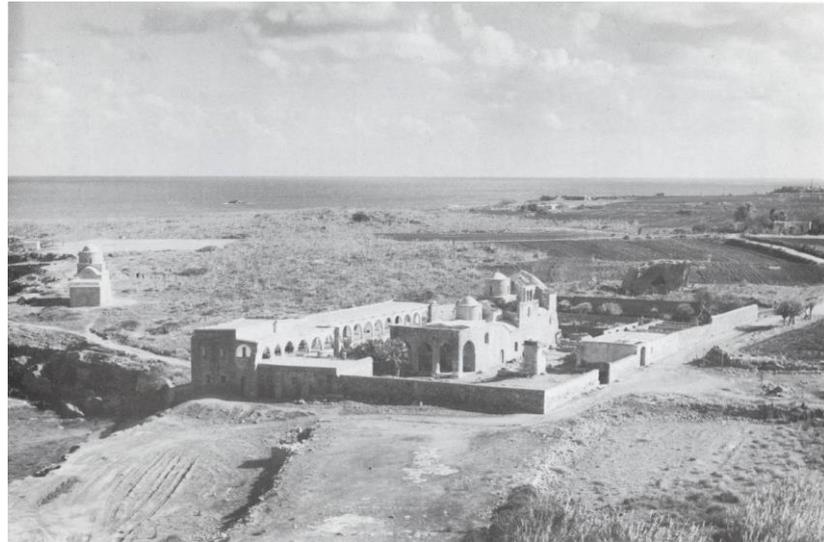
Figure 21. Image of the monastery complex from 1930's (Enlart, 1987)

This arcade building is located to the south of the church. It has a rectangular shape and two large rooms with interior columns and arches. The exact date of the building is not known, but what is clear about this building is that the two rooms were built in different periods. It cannot be discerned whether the building is under construction or undergoing repairs, but there is an old photograph from the 1930s (Figure 21) (Enlart, 1987). As (Hanworth, R. & Pollock, 1992) suggest, construction of the buildings started around the church in the twelfth century.

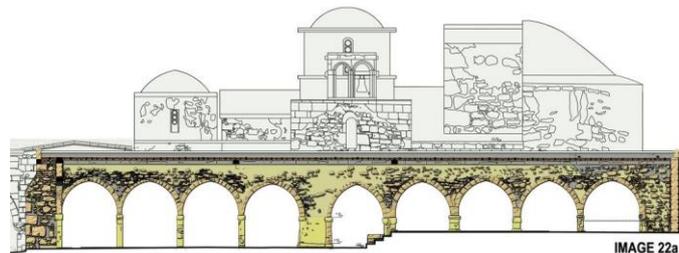
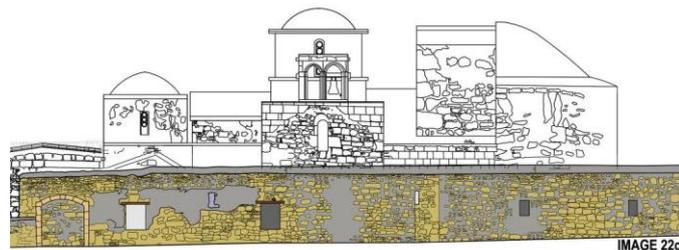
Figure 22. (a) Longitudinal section of the south wing building from arcade (b) Survey drawing of the south wing building, north elevation (c) Survey drawing of the south wing building, south elevation

The two rooms I-G 01 and I-G 03 can be dated to different periods because of the abundance of traces of different constructions and differences in architectural styles. Firstly, the rooms have a significant height difference: 92 centimetres (Figure 22a). The designs of columns that are used for the arcade change at the juncture between these two rooms (Figure 22b). The window organisation from the west side appears to be the same; however, the organisation in the south area is totally different. Furthermore, the sharp vertical line of a change in the masonry style at the south façade gives the sense of an abrupt separation (Figure 22c).

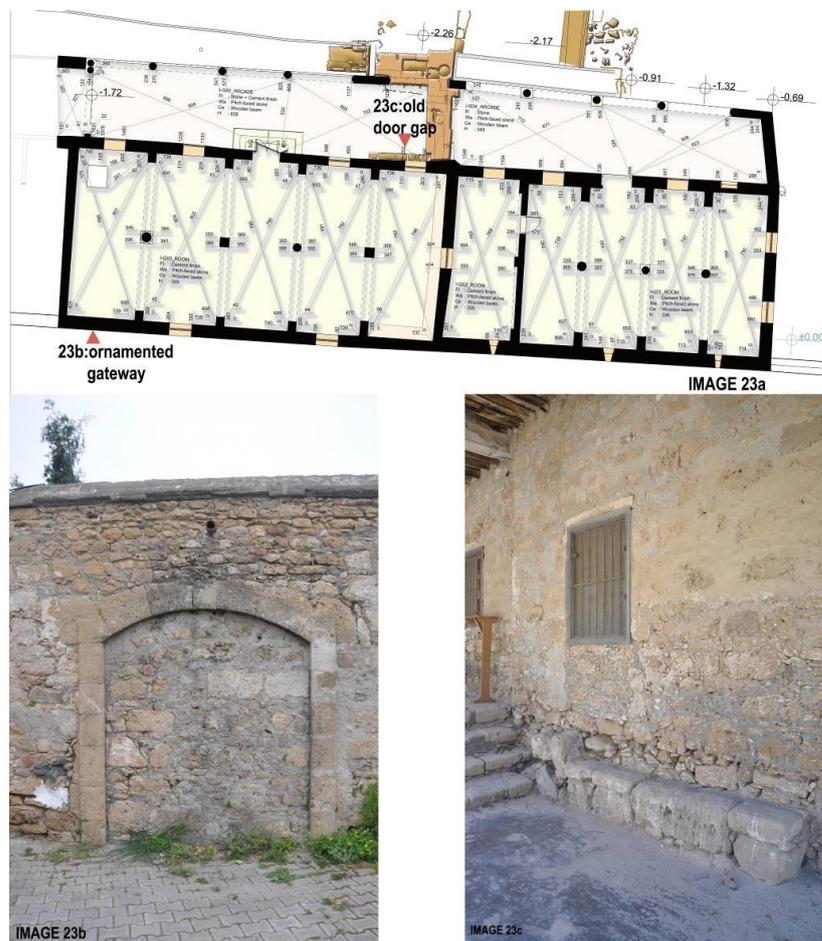
Figure 23. (a) Survey drawing of the south wing building, ground floor plan (b) Image of the ornamented gateway from south elevation (c) Image of the wall from arcade

I-G 02 is a small room, which must have been separated from room I-G 01 at a later stage; the two rooms were once one space (Figure 23a). Room I-G 03 also displays traces of accumulation. There is an entrance at the end of the west side of the room, but it is not visible from the inside. The south façade of the building has a large ornamental gateway (Figure 23b), which unfortunately has been filled with stone masonry. Inside this room towards the arcade side, a faint line can be seen on the surface under the window, which gives the impression of an old doorway (Figure 23c). Here the cluster of stones within the masonry could be the step of a former stairwell.

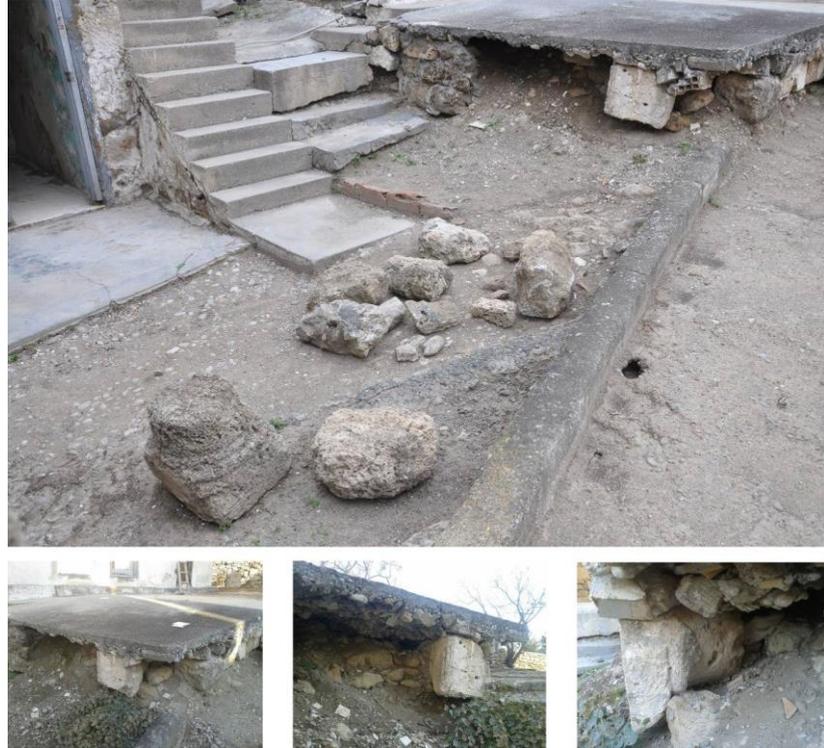
Figure 24. Image of the antique column base under the concrete platform

the walls are composed of reused material, including antique column bases (Figure 5); for example, the concrete platform in front of the showers was built on a foundation formed by reused antique stones of the site. The base and body of a huge antique column can be seen in a large gap under the platform (Figure 24).
